# **Field Report for Airborne Data Collected In Support of US EPA Region 6 Intercontinental Terminals Company LLC Fire 25 March 2019**

### **Data Results Flight 12, 25 March 2019**

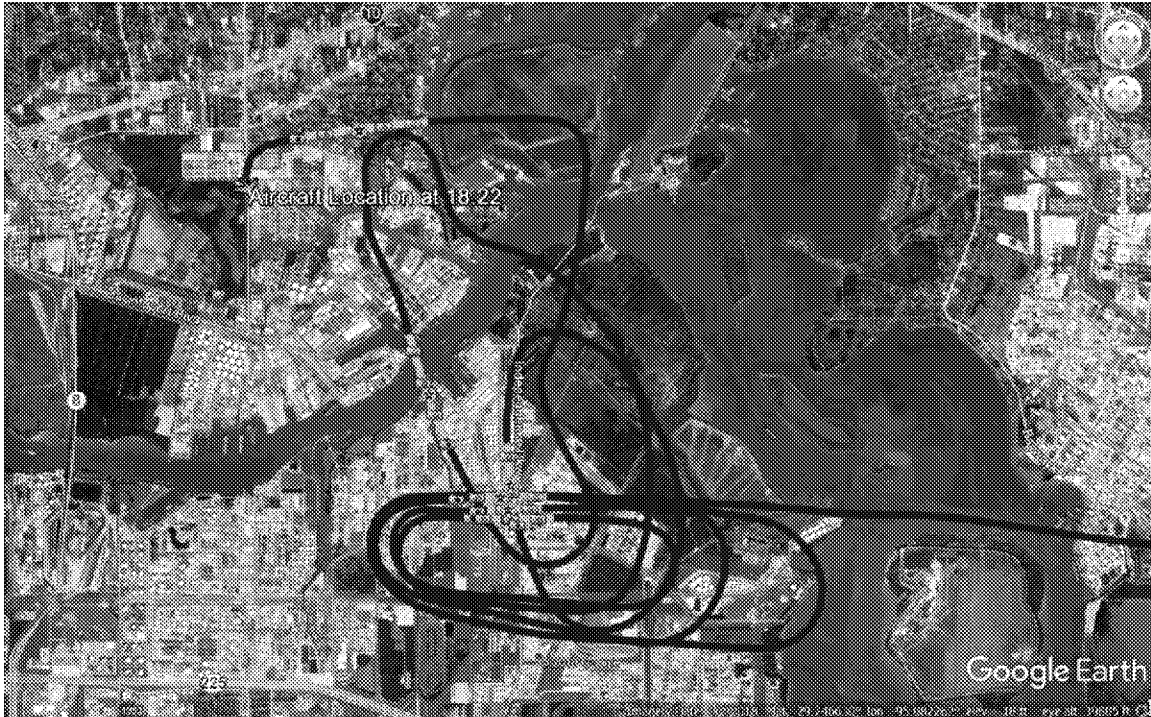
The order to launch the aircraft was given at 1230 local on 25 March 2019 and the aircraft was airborne at 1240. The initial data collection run over the site was at 1258 (local) and the aircraft made a total of 6 data collection passes. No detections were observed on any passes. Flight information is summarized in Appendix A and Figure 2.

Figure 2: Flight line data for 25 March 2019, Flight 12. The blue lines represent the ASPECT flight path, green lines represent when the Infrared Line Scanner was actively collecting data, and the camera icons represent when a photo was taken.

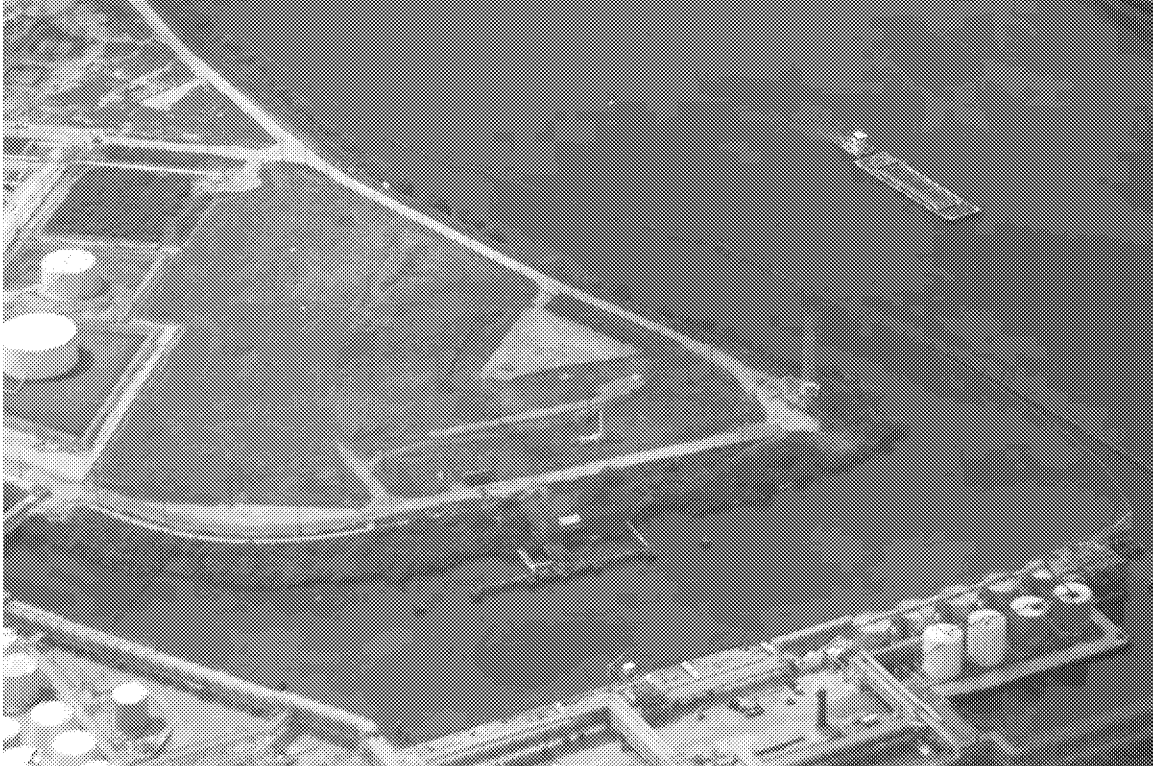
A full set of high resolution aerial digital photography was collected as part of the flight. Figure 6 shows a representative overhead image collected as part of each pass over the tank farm. As with prior flights, the image shows that oil product is captured behind the boom. Sheen can be seen escaping from the boom with movement toward the southwest as driven by the winds. The same area as viewed with an oblique does show captured product but the definition is much reduced as compared to the IR or aerial view (Figure 7). Some sheen can be seen in the right bottom corner of the image.

Figure 7: Oblique Image of the Ship Channel Boom Area, 23 March 2019, Flight 10
